Pedestrian Safety Countermeasures Along Delaware's SR 1 Beach Corridor

Roadway Management Conference 2021

Peter Haag, P.E., PTOE
Delaware Department of Transportation
Chief of Traffic Engineering

Kyle Clevenger, P.E., PTOE
Whitman, Requardt & Associates, LLP
Senior Project Engineer

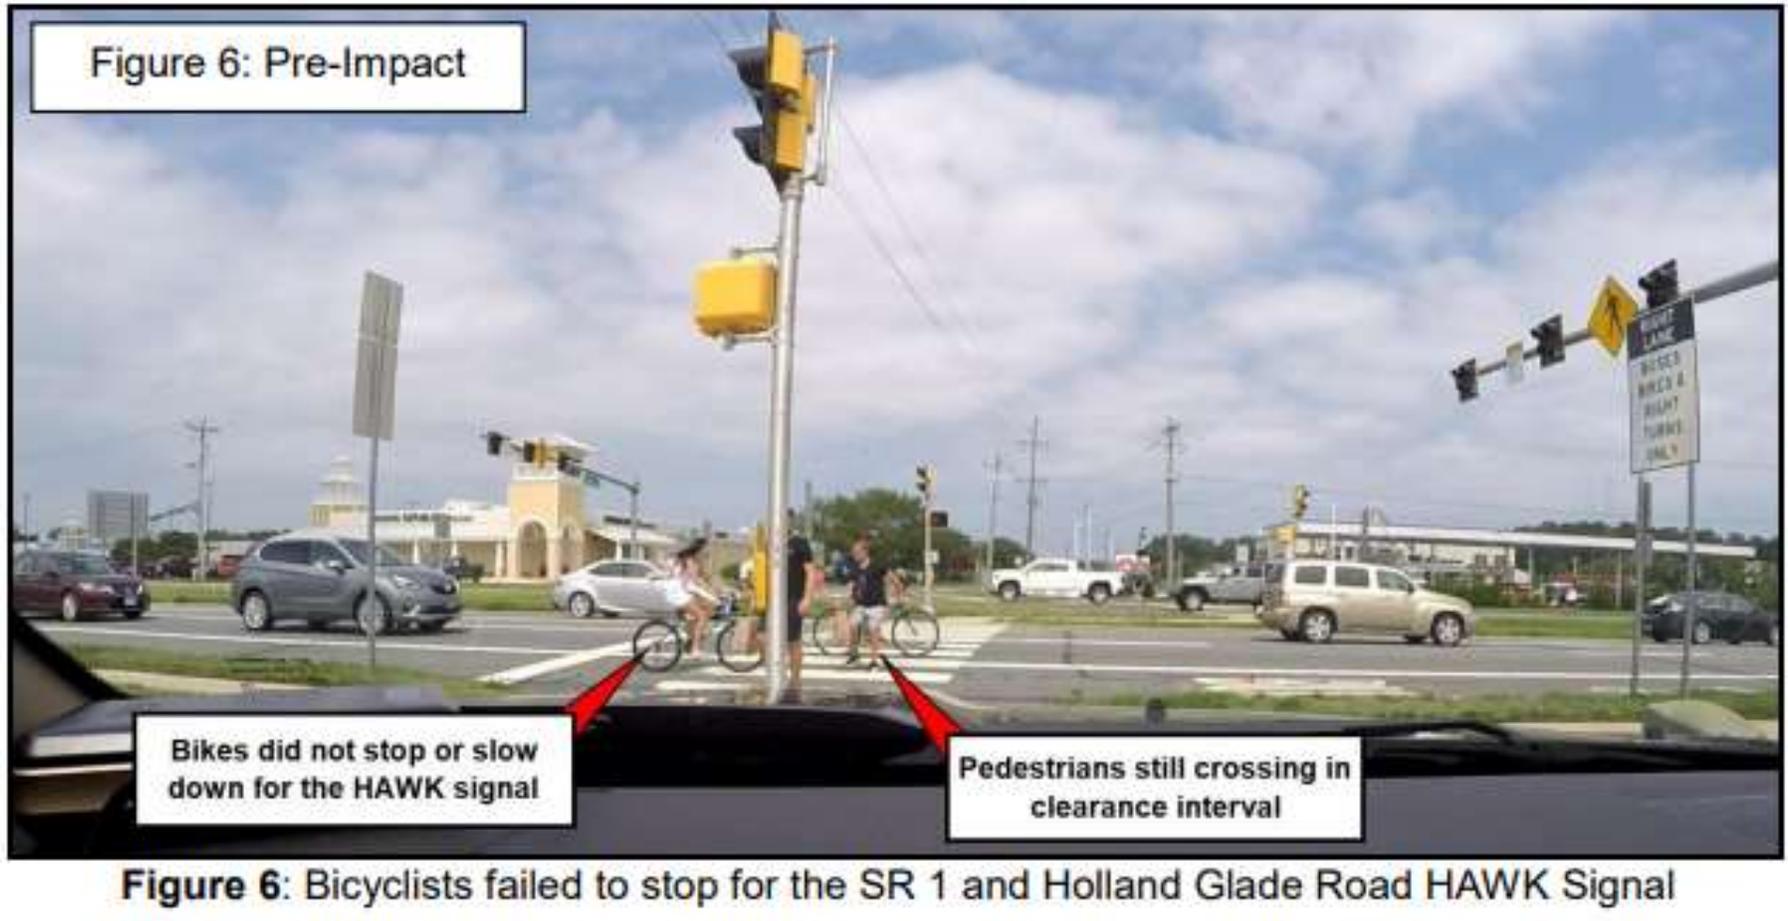
SR 1 HAWKs – Examples of Non-Compliance and Confusion

- SR 1 at Rehoboth Avenue:
 - Motorist Compliance down from 87% in 2016 to 59% in 2019
 - Pedestrians and bicyclists frequently activate HAWK, but cross before the HAWK signal activates. Subsequently, many non-complying vehicles observed when no pedestrians or bicyclists are present
 - Total crashes have increased by 27% since installation
 - Zero bike/ped crashes prior to installation; 1 pedestrian and 3 bicycle crashes since installation, although none attributable to the HAWK signal
 - Westbound pedestrians less likely to wait for the HAWK signal to activate and cross properly after completing 3 previous stages of the crossing (4-stage crossing of SR 1 / SR 1A)

- SR 1 at Holland Glade Road:
 - Motorist Compliance down from 97% in 2016 to 72% in 2019
 - Pedestrians and bicyclists frequently activate HAWK, but cross before the HAWK signal activates. Subsequently, many non-complying vehicles observed when no pedestrians or bicyclists are present
 - Motorists observed speeding up during flashing yellow to “beat the light”
 - Total crashes have increased from 29 to 62 since installation of the HAWK
 - Bicycle crashes increased from 1 to 8 since installation of the HAWK signal, including one involving a bicyclist being hit by a motorist that disregarded the signal and 3 other crashes attributed to the HAWK

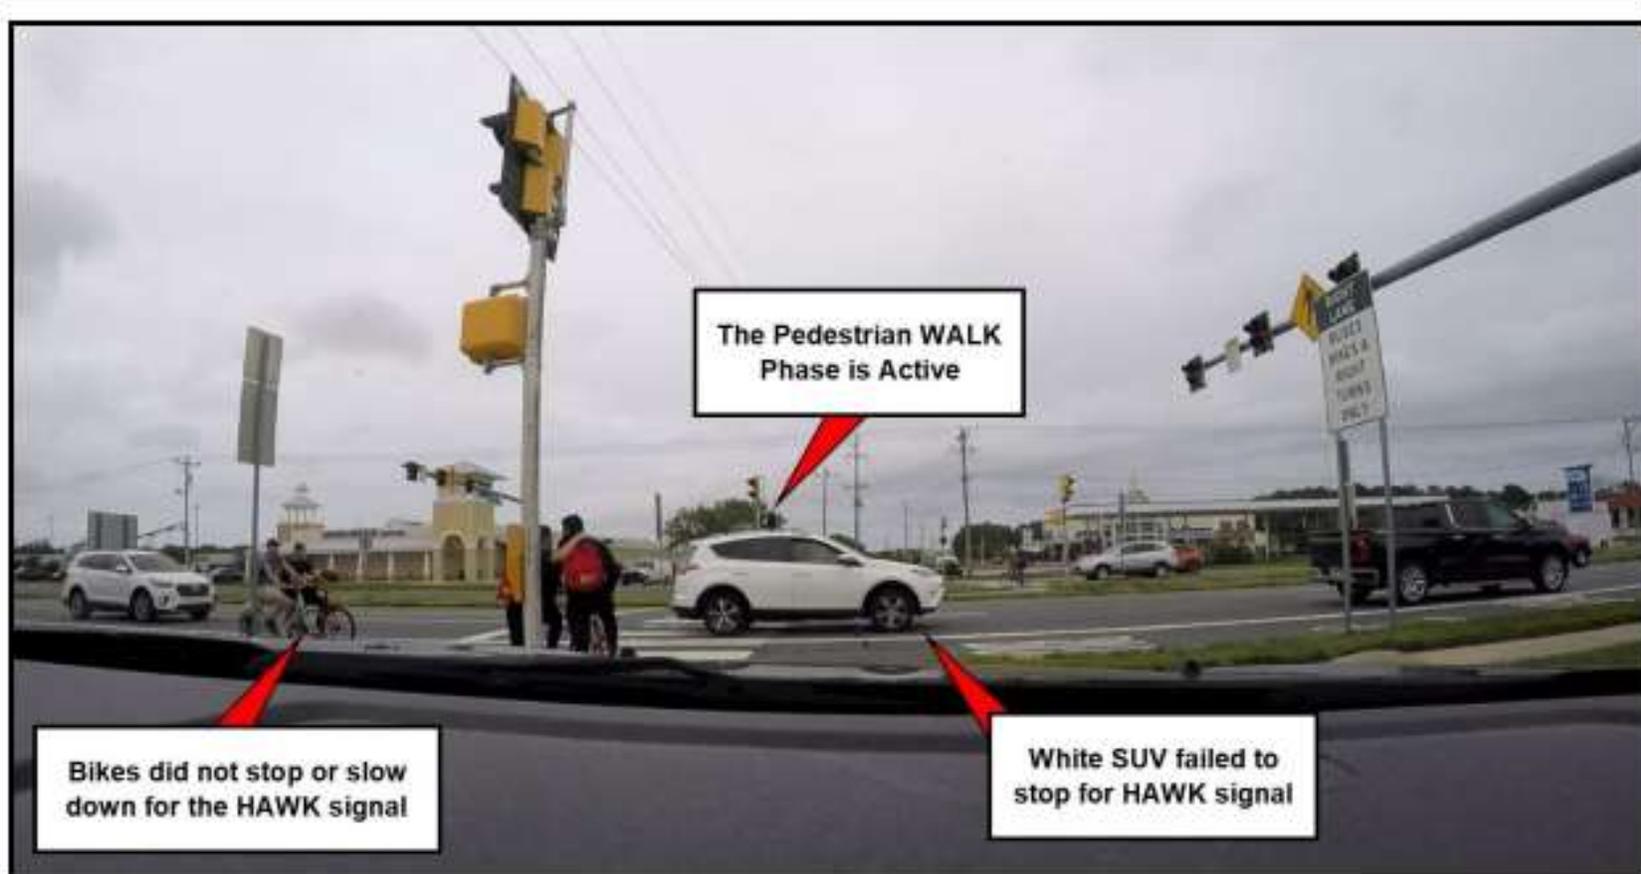
SR 1 HAWKs – Examples of Non-Compliance and Confusion

Figure 8: Examples of conflicts at SR 1 and Holland Glade Road HAWK Signal
